DEPARTMENT OF TRANSPORTATION

Contract #: 04-0120F4Cty: SF/ALA Rte: 80 PM: 13.2/13.9File #: 69.28**WELDING INSPECTION REPORT****Resident Engineer:**Pursell, Gary**Address:** 333 Burma Road**City:** Oakland, CA 94607**Report No:** WIR-001852**Date Inspected:** 21-Mar-2008**Project Name:** SAS Superstructure**OSM Arrival Time:** 630**Prime Contractor:** American Bridge/Fluor Enterprises, a JV**OSM Departure Time:** 1730**Contractor:** Zhenhua Port Machinery Company, Ltd (ZPMC), Changxing Island **Location:** Shanghai, China**CWI Name:** See below**CWI Present:** Yes No**Inspected CWI report:** Yes No N/A**Rod Oven in Use:** Yes No N/A**Electrode to specification:** Yes No N/A**Weld Procedures Followed:** Yes No N/A**Qualified Welders:** Yes No N/A**Verified Joint Fit-up:** Yes No N/A**Approved Drawings:** Yes No N/A**Approved WPS:** Yes No N/A**Delayed / Cancelled:** Yes No N/A**Bridge No:** 34-0006**Component:** OBG/Tower**Summary of Items Observed:**

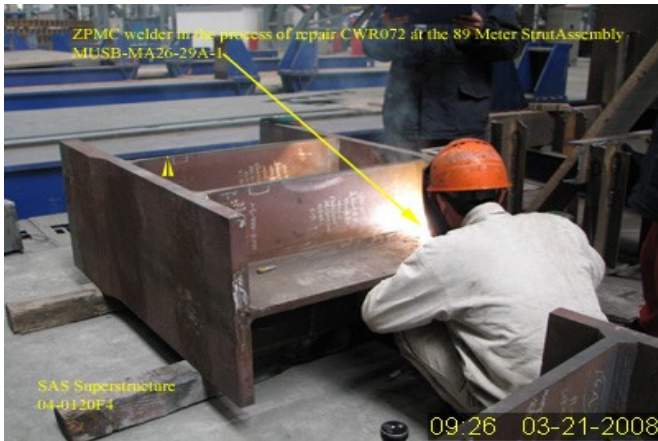
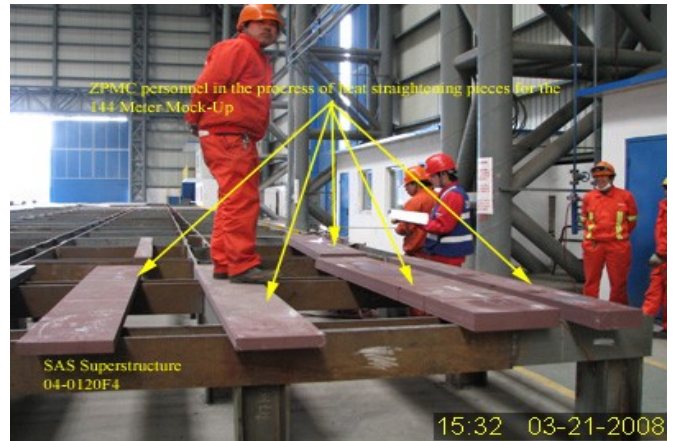
The following digital photograph below illustrates observation of the activities being performed.
